Manhole Inspection Summary

Manhole # S43W__039MH

Insp Date: **3/4/08 1:53 PM**

Location Address: **rear 1341 e. clement st.**

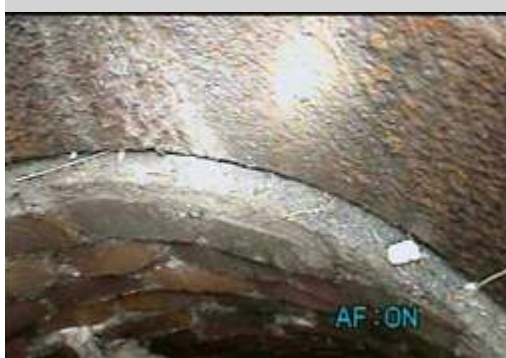
Defect 2

Frame Offset: **1.5** (in.) Condition: ☒ Sound ☐ Cracked ☐ Leaks

off set defect

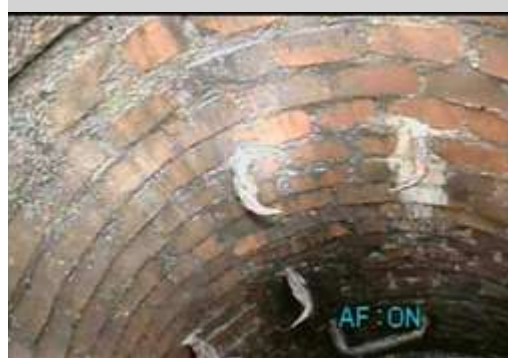
Defect 1

Steps Count: **3** Missing: **2** ☒ **Corroded**

steps corroded and missing

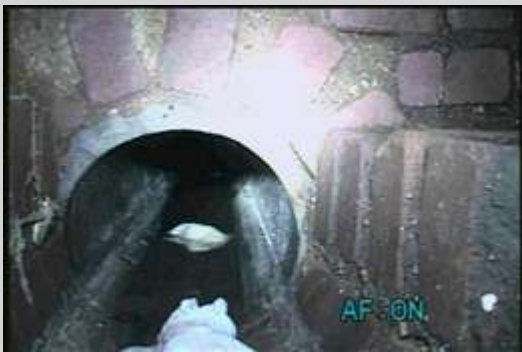
12 O'Clock Outflow

8 in. Circular Gravity Sewer
Pipe Out @ 12 O'Clock

Pipe Material: **Clay** ☐ Pipe Lined

Invert Depth: **7.30** (ft.) Flow Characteristics: **Slow**

Deposits: ☒ None ☐ Mud ☐ Sludge ☐ Debris ☐ Grease

Infiltration: **None** Pipe Seal Cond: **Unknown**

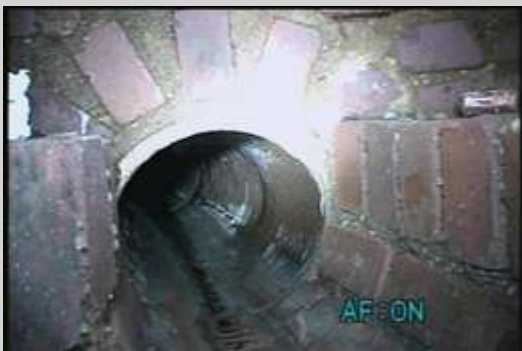
3 O'Clock Inflow

8 in. Circular Gravity Sewer
Pipe In @ 3 O'Clock

Pipe Material: **Clay** ☐ Pipe Lined

Invert Depth: **7.20** (ft.) Flow Characteristics: **Slow**

Deposits: ☒ None ☐ Mud ☐ Sludge ☐ Debris ☐ Grease

Infiltration: **None** Pipe Seal Cond: **Unknown**
